Arboricultural Impact Assessment & Method Statement

Trewythen Hall, Vicarage Lane, Gresford

Our Ref: 23/AIA/WXM/311

February 2023

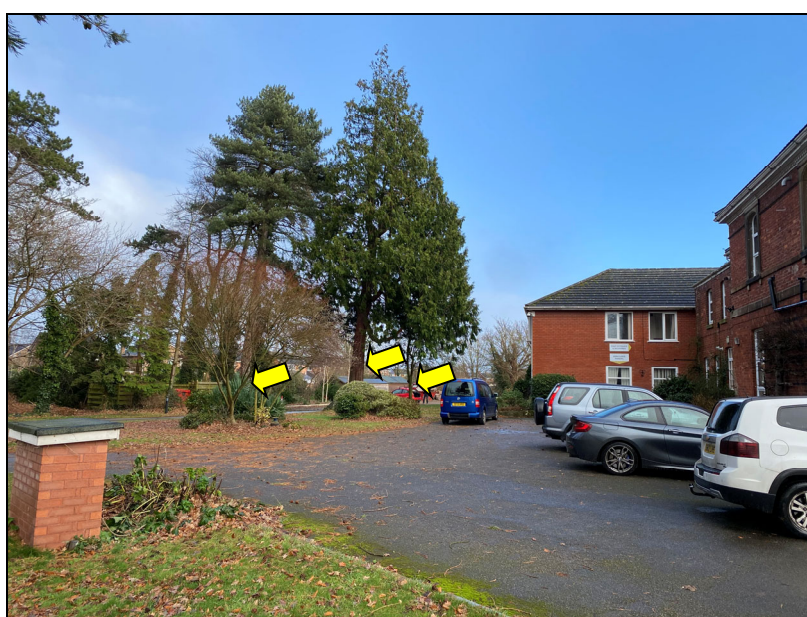
P1 – Tree numbers 1, 2 & 6 to be removed

- 8.2 In order to accommodate the proposed new access road alignment and ensure a good easement to the extension to the northern gable it will be necessary to remove tree numbers 1, 2 and 6. The impact of this will be negligible as tree numbers 1 & 2 are small specimens that can be easily replaced by new planting that will quickly establish in the space available. Tree number 6 is a larger, mature specimen but not one that is considered outstanding or pivotal to the landscape character and setting of the site. It has an asymmetrical crown form, and a large pruning wound at the base at the point of removal of the secondary leader to the west. Removing this tree will open a clear vista to the larger and better-quality trees located immediately north (T3-T5). The Pines (T3 & T5) will become the real feature trees in this area of the grounds with adequate space being provided for some good quality specimen planting provision within the new grassed island as mitigation. As such, we are satisfied that the loss of these trees will be largely unnoticed and new planting will ensure good quality, appropriate succession planting for the enjoyment of future occupants.

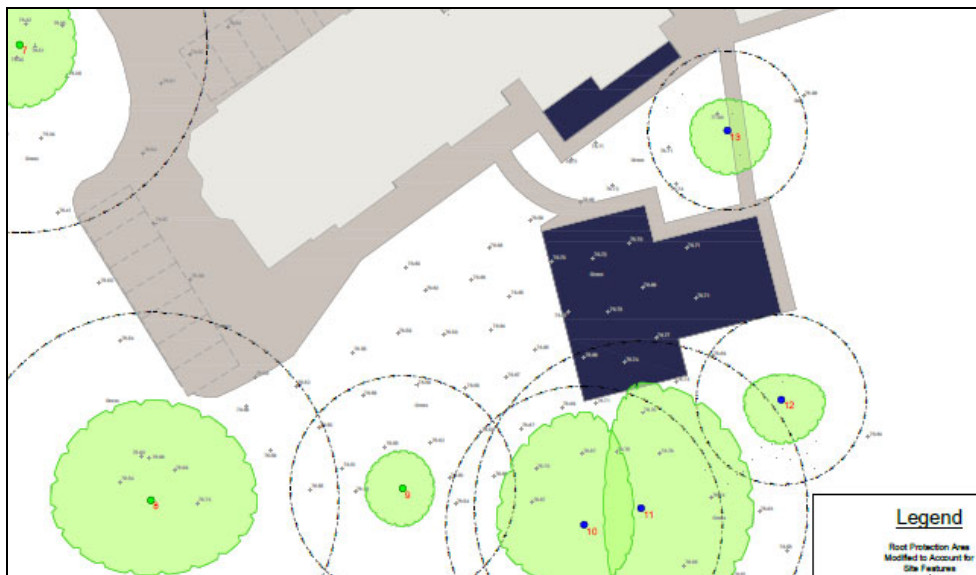
P3 – Original location of fitness suite within RPA of T11 & footpath through T13

- 8.3 The proposed new fitness suite to the south of the hall has been redesigned following receipt of the tree survey and constraints plan. It now falls outside the designated RPA of all trees and at a sufficient distance to ensure no adverse construction impacts or issues of resentment towards the trees in the future. The amenity and landscape value they afford the grounds will therefore be maintained.
- 8.4 There are no other development impacts to trees as the external works have largely been kept within the existing alignment.

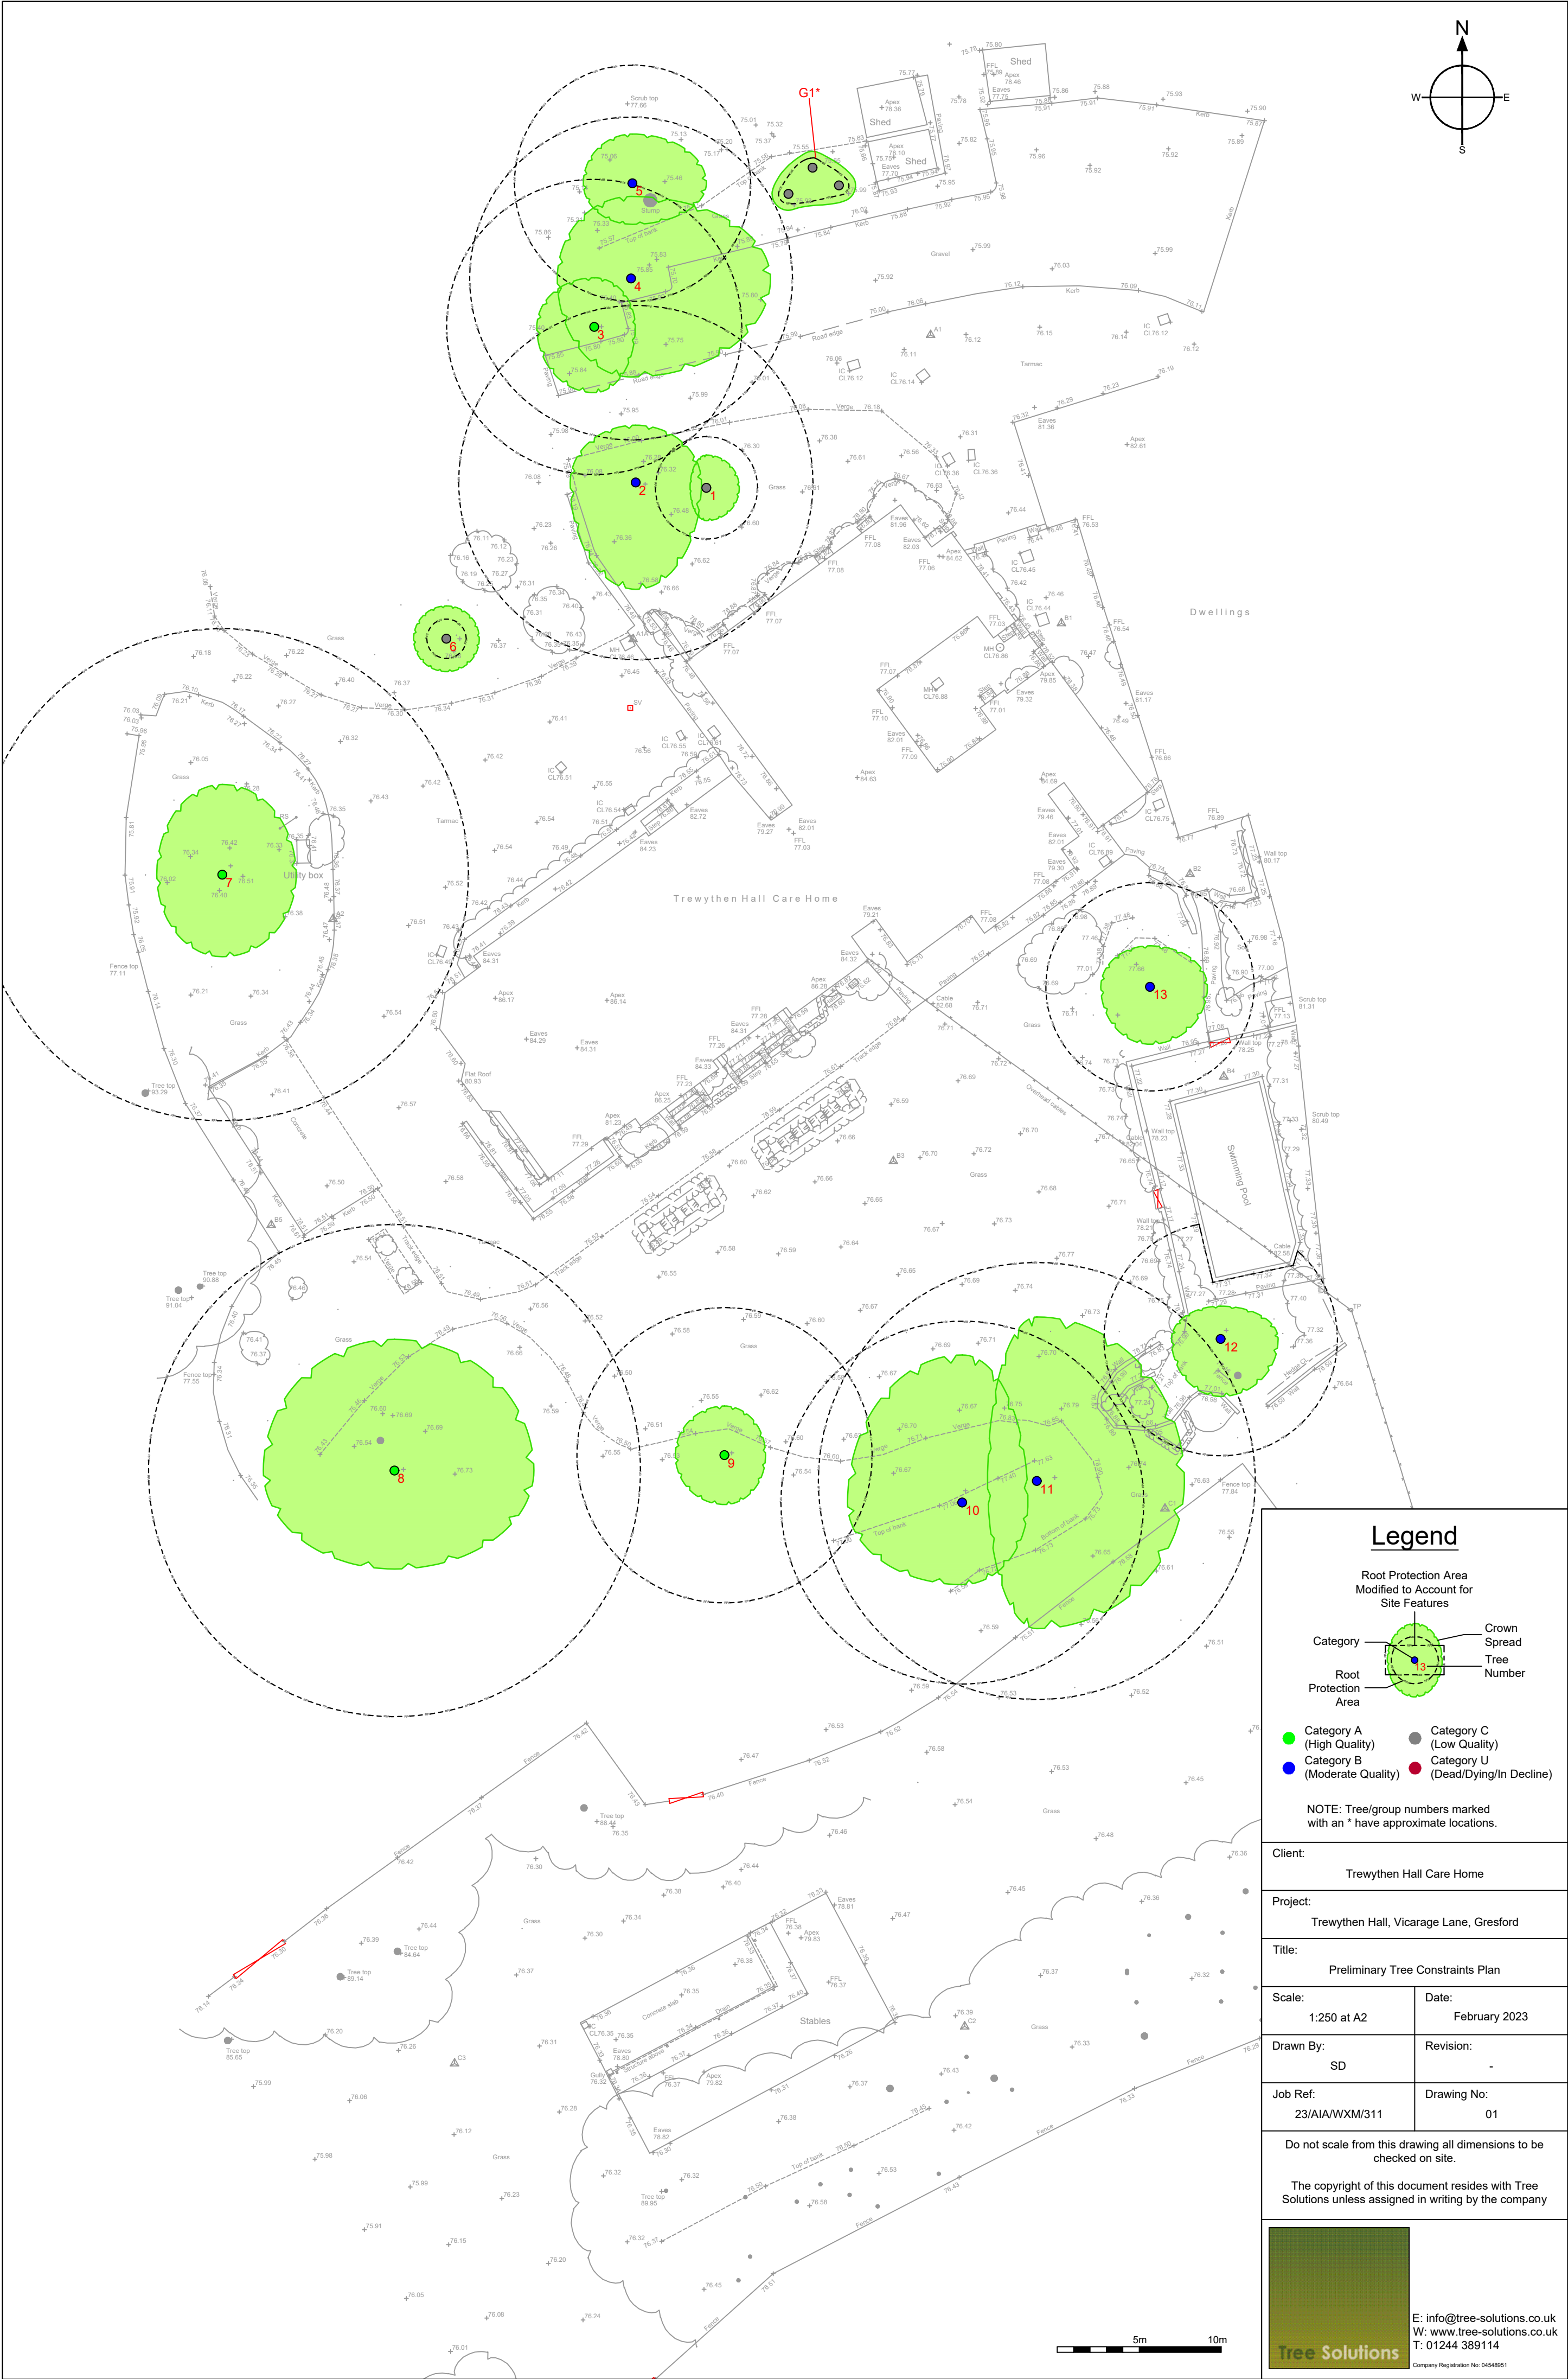
Appendix Two
Preliminary Tree Constraints Plan

Client:		Trewythen Hall Care Home	
Project:		Trewythen Hall, Vicarage Lane, Gresford	
Title:		Preliminary Tree Constraints Plan	
Scale:	1:250 at A2	Date:	February 2023
Drawn By:	SD	Revision:	-
Job Ref:	23/AIA/WXM/311	Drawing No:	01
Do not scale from this drawing all dimensions to be checked on site.			
The copyright of this document resides with Tree Solutions unless assigned in writing by the company

- 1.4 Thirteen individual trees (T1-T13) and one group (G1) were surveyed and mapped on a Preliminary Tree Constraints & Impact Assessment Plan Ref: 23/AIA/WXM/311, Drawing No. 1 & 2 at **Appendix 2**. All arboricultural information recorded during the survey is presented within a schedule at **Appendix 1**.

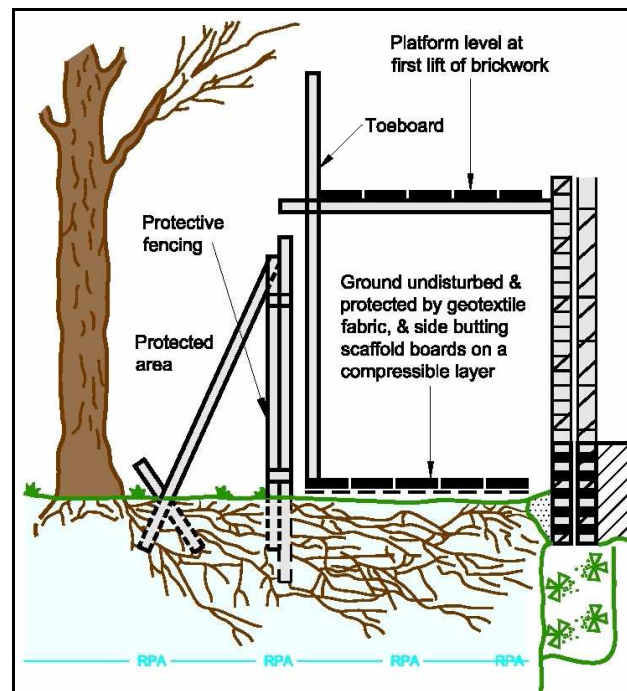
Plate 2- protective boards & scaffolding to be installed

1. Ground protection shall be installed prior to commencement of any construction work on site and shall be in accordance with the specification in plate 1 below.
2. The ground beneath any protection boarding will be left undisturbed and will be protected with a porous geotextile fabric and side butting scaffold boards on a 100mm compressible layer such of sharp sand
3. Boards will remain in-situ until the construction of the building has been completed

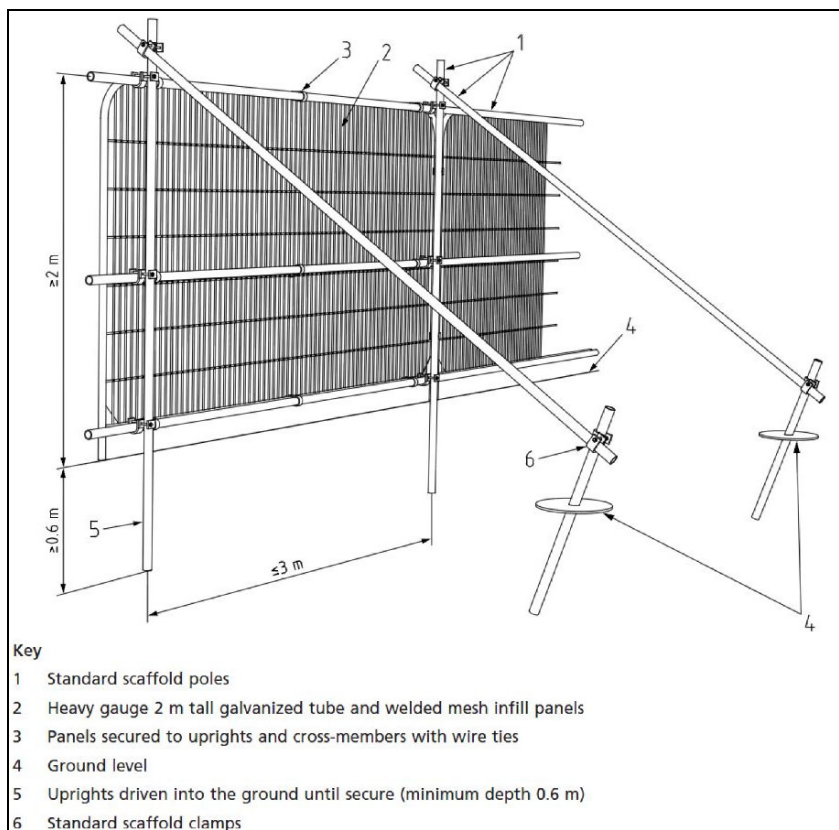
Tree Protective Fencing Specification

2.0M high heavy-duty Heras panels (with extra central support bar) mounted on scaffold poles (driven into the ground) and secured with anti-tamper bolts – as illustrated below.

- 2 The fencing will consist of a scaffold framework in accordance with Figure 2 of BS 5837 – 2012 (illustration below) comprising a metal framework, both vertical and horizontal, well braced to resist impacts. Vertical tubes will be spaced at a maximum interval of 3m. Onto this, weldmesh panels shall be securely fixed with wire or scaffold clamps. Weldmesh panels on rubber or concrete feet are not considered resistant to impact and for this reason will not be used. The site manager or other suitably qualified appointed person will be responsible for inspecting the protective fencing on a daily basis; any damage to the fencing or breaches of the fenced area will be rectified immediately.
